Western Fire Center, Inc.

Fire Performance of ASTM E119 Evaluation of a Non-Load-Bearing Wall Assembly with Flat Strap Backer

Indicative testing conducted in accordance with the test methodology described in ASTM E119, Standard Test Methods for Fire Tests of Building Construction and Materials

WFCi Report #12142r1

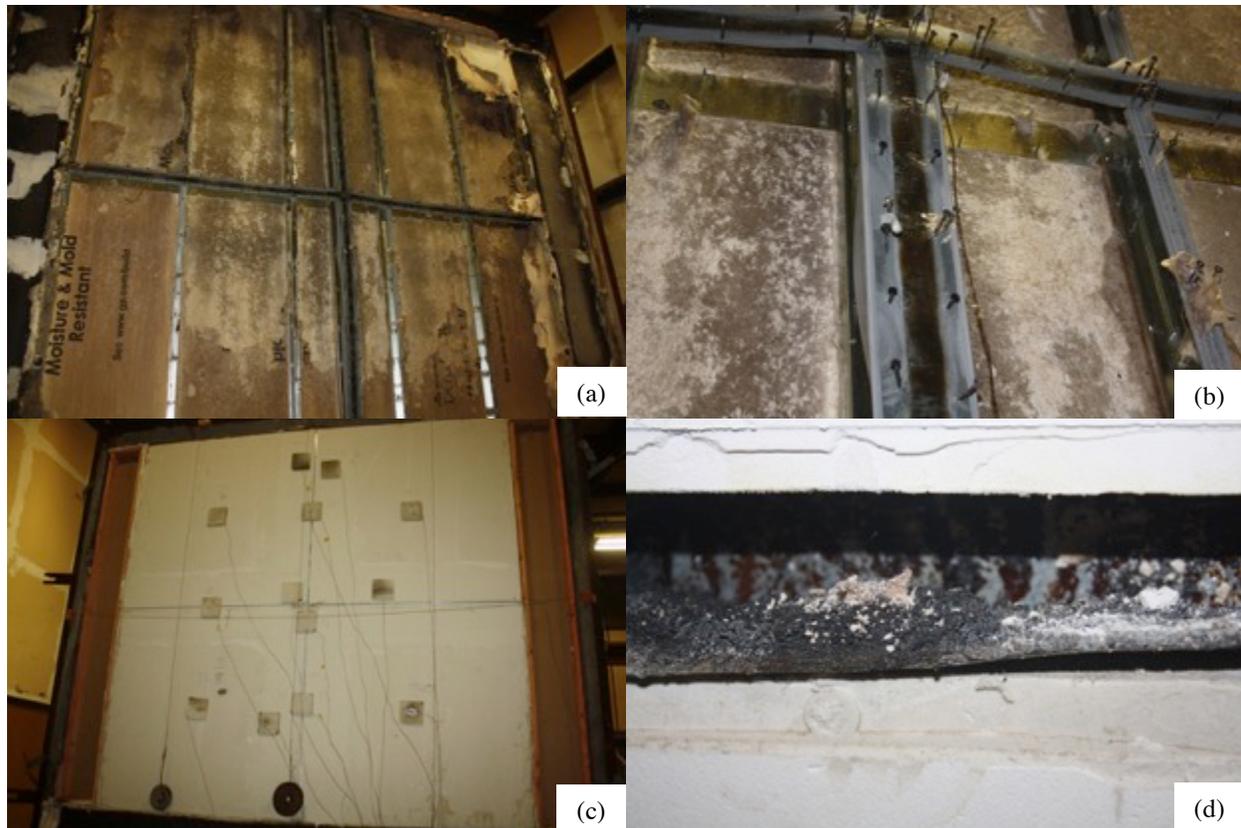
Figure 10. Post-test photographs showing (a) exposed assembly, (b) close-up of horizontal and vertical FSB, (c) unexposed assembly, and (d) unexposed FSB strip on unexposed side of assembly.

After the fire resistance and hose stream test, the exposed section of the assembly was torn completely gone, leaving only the steel FSB strips and sideways stud. The unexposed GWB was mostly intact with only some deterioration on the paper face (Figure 10). The DRM strip was removed from the assembly to analyze the FSB intumescent strip, which appeared to swell between 1/8" - 1/4". It appeared that the material behaved as designed, allowing the jointed wall to pass the necessary requirements.
